PASSAIC RIVER BASIN
TRIBUTARY TO PEQUANNOCK RIVER
PASSAIC COUNTY
NEW JERSEY

HIGH CREST LAKE DAM NJ 00225

PHASE 1 INSPECTION REPORT NATIONAL DAM SAFETY PROGRAM

May. 1979

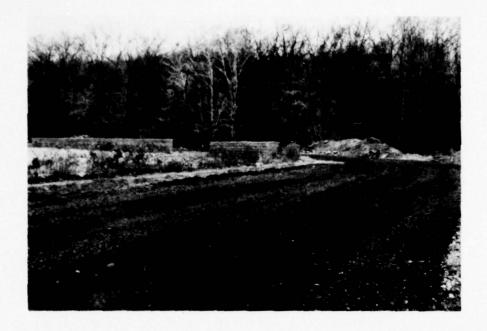
erosion, cracking and any other evidence of undesirable behavior which might affect the stability of the structure. The crest of the dam is obscured by a roadway (Photo 1), and the downstream embankment is entirely covered by material from the roadway embankment (Photo 2). The road was being surfaced with asphalt at the time of inspection, thus any cracking or misalignments in the crest could not be observed. The top of the concrete core wall was exposed for about 40 feet to the left of the spillway, in an area not covered by the road paving (Photo 3). This would indicate that there has been some minor erosion or settlement of the embankment.

Photo 1 - Freshly surfaced roadway along crest of dam, looking east.
(December 3, 1978)

- (2) The spalled and eroded concrete facing of the spillway weir should be repaired and the wing walls should be replaced or repaired as needed.
- (3) The roadway material covering the downstream face of the dam which is now, in effect, the face of the dam should be graded to a slope of 2H:1V and either seeded with grass or covered with stone.

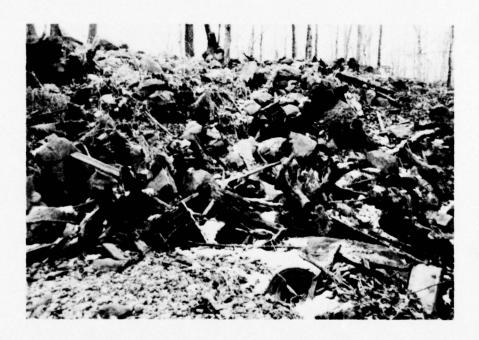
Photo 2 - Debris and trash covering downstream embankment.
(December 3, 1978)

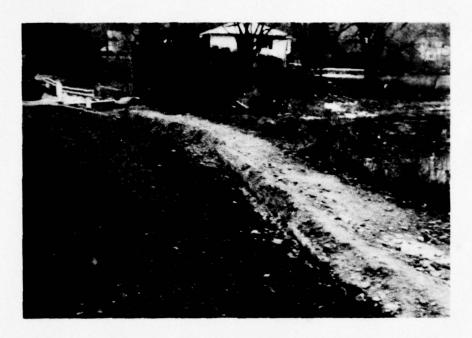
Photo 3 - Exposed top of concrete core wall to right of pavement.
(December 3, 1978)

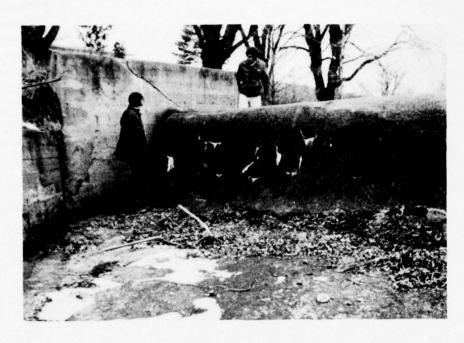
The spillway is in need of repair. There is local spalling and cavitation to a depth of 1-1/2 inches along the crest of the weir (Photo 4), and there are small cracks filled with leaching deposits on the downstream side of the weir (Photo 5). The downstream toe of the weir is eroded and rough (Photo 5). The weir has been patched at a number of places, including the spalled downstream surfaces adjoining a construction joint. There is a large pile of rocks on the upstream left side of the spillway (Photo 6).

Photo 5 - Leaching deposits (white areas) along cracks in spillway weir, and erosion of concrete at base of weir.
(December 3, 1978)

- The seepage at the toe of the lined spillway channel should be assessed by a qualified professional engineer, and any necessary corrective action taken. If necessary, piezometers should be installed in adjacent areas of the embankment and abutment to monitor the phreatic surface.
- The spalled and eroded concrete facing of the spillway weir should be repaired and the wing walls should be replaced or repaired as needed.

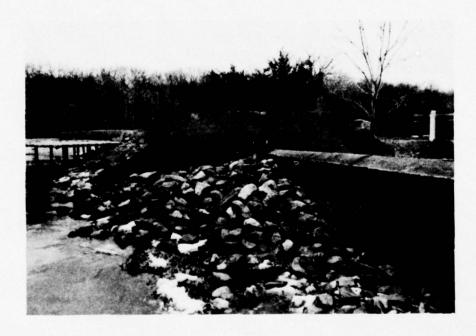
Both wing walls of the spillway have failure cracks. The left wing wall has a 3/4-inch wide vertical crack above the crest of the weir (Photo 6), while the right wing wall has a sloping crack about 20 feet long extending from the upstream training wall to well downstream of the weir (Photo 7). There is horizontal displacement along the cracks in both wing walls, leaving no doubt that the wing walls have failed and are no longer safely performing their function.

Photo 6 - Rocks piled up behind spillway.
Note crack in left wing wall.
(December 3, 1978)

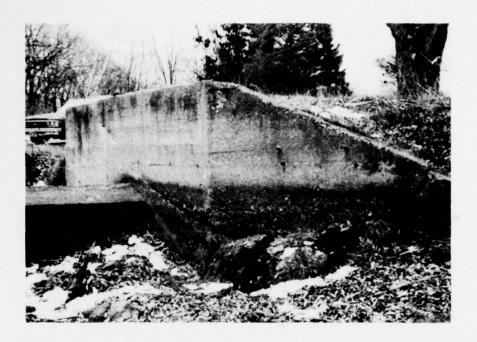
Photo 7 - Crack in right wing wall of spillway, looking downstream. (December 3, 1978)

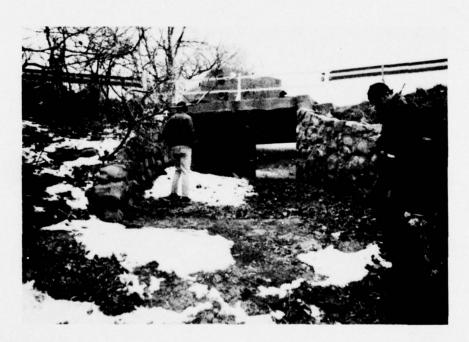
Photo 8 - Bridge downstream of spillway, looking north toward spillway. (December 3, 1978)

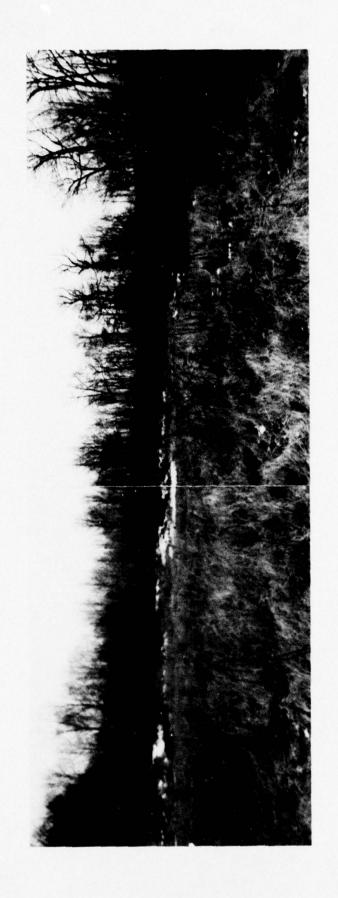
Photo 9 - Downstream area. Stream channel hidden by brush on right.
(December 3, 1978)
